# HUMBUG CREEK WATERSHED ASSESSMENT AND MANAGEMENT RECOMMENDATIONS

*A pilot assessment of mining impacts and recommendations for action  
to improve water quality at Malakoff Diggins State Historic Park*

The Sierra Fund

April 2015

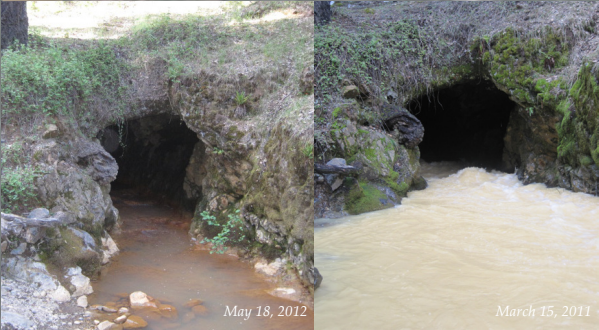
**Hiller Tunnel Discharge at Low and High Flow:** Hiller Tunnel is the only visible surface water discharge location of the Malakoff Diggins pit. It has year round flow, and discharges vast amounts of turbid water during storm events.

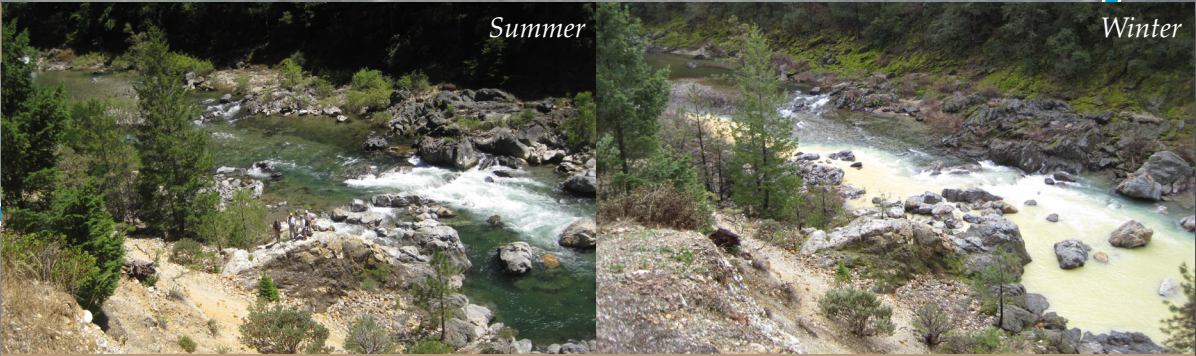
**Confluence of Humbug Creek and the South Yuba River: Summer and Winter:** Humbug Creek enters the South Yuba River at the top left of these photos. In the summer (left) there is no visible discharge, but in the winter after a storm event the mixing zone of turbid water from Humbug Creek into clear water from upstream in the South Yuba is apparent. The turbid water continues at least ten miles downstream.

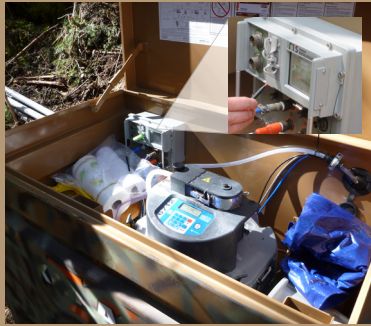
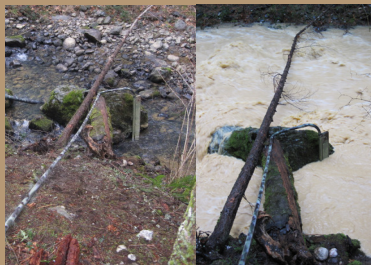
HUMBUG CREEK ANNUAL LOAD ESTIMATES

Water quality monitoring sites were established on Humbug Creek upstream of the discharge from Hiller Tunnel at the Relief Hill Road crossing (Road 1), from the Hiller Tunnel discharge (Hiller 2) and downstream of the confluence of Diggins Creek on Humbug Creek (Gage 3). Monitoring equipment including stage and turbidity meters shown to the right was installed at the Gage 3 site. This equipment, shown to right during low and stormflow, was used to measure turbid surface water runoff containing particulate-bound metals during storm events, caused by ongoing erosion from the Malakoff Diggins pit.

- 1. The Malakoff Diggins pit drains via Diggins Creek and contributes sediment and particulate bound mercury, and other metals to Humbug Creek.
- 2. **Humbug Creek contributes an estimated 500 tons of sediment and an estimated 100 g of mercury to the South Yuba River per year, during a dry or below normal year.**
