HUMBUG CREEK WATERSHED ASSESSMENT AND MANAGEMENT RECOMMENDATIONS

*A pilot assessment of mining impacts and recommendations for action
to improve water quality at Malakoff Diggins State Historic Park*

Humbug Creek Watershed Assessment and Management Recommendations

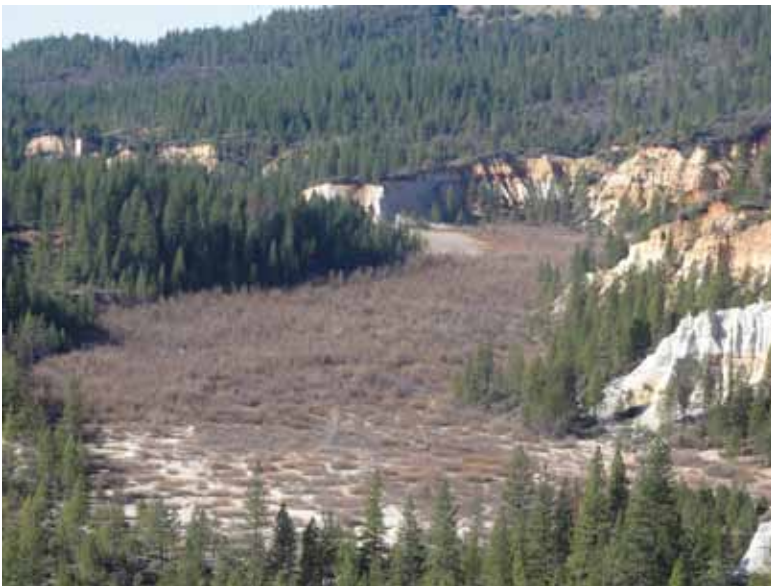
Figure 2. View of Malakoff Diggins Pit Looking West from the Chute Campground Overlook

The excavation left by hydraulic mining exposes Paleozoic-aged metamorphosed igneous and sedimentary rock. The pit is over a mile long, 1,000 ft wide in places, and up to 600 ft deep. The surrounding forest is primarily mixed conifer and oak woodland. The pit floor is vegetated by willows. There is a pond in the far west end of the pit. (Photo taken October 9, 2013 by C. Monohan.)

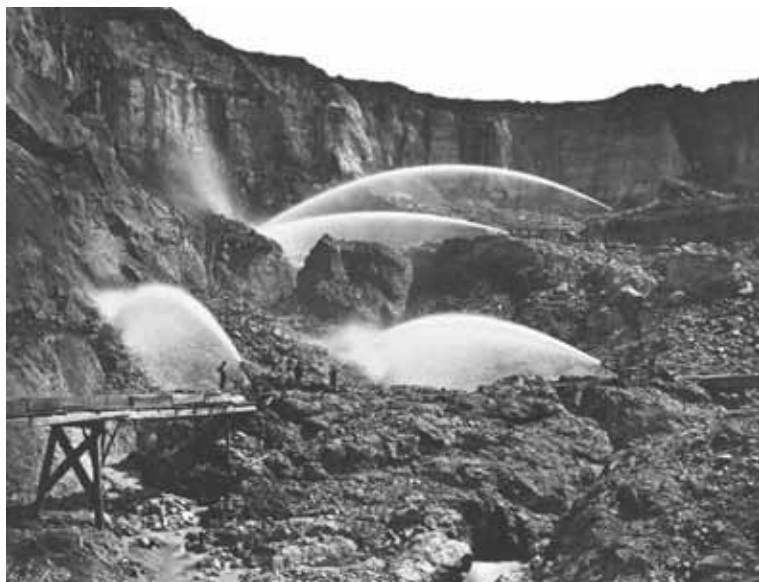
Figure 5. Peak Hydraulic Mining Operations at Malakoff Diggins

Hydraulic mining monitors were used to direct powerful streams of water to wash down hillsides in search of gold bearing gravels. Seven monitors ran day and night. (Photo courtesy of California Department of Conservation, California Geological Survey Library.)

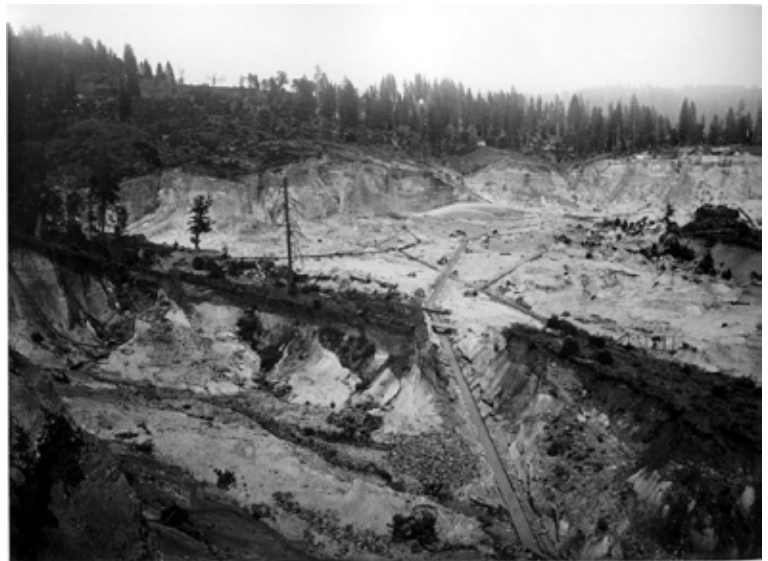
Figure 6. Sluices on the Malakoff Diggins Pit Floor

Mine debris was washed into sluices that were laced with mercury to pull fine grained gold out of the sediment. The pit floor has a series of sluices which directed the slurry to the North Bloomfield Tunnel, the first 580 m (1,900 ft) of which was used as a tunnel sluice.

In addition to placing mercury into sluices and gravels, a tunnel sluice² was created by adding mercury by the flask-full to the first 580 m (1,900 ft) of the North Bloomfield Tunnel (Jackson, 1967). At the outlet of the North Bloomfield Tunnel, mine debris was discharged into an extensive series of flumes and mercury-laden undercurrents. These flumes and undercurrents eventually emptied into the South Yuba River at two locations, approximately 800 m (0.5 mi) and 200 m (700 ft) vertically below the mouth of the North Bloomfield Tunnel (Jackson, 1967). Between 1866 and 1900 about 20,000,000 m³ (30,000,000 yd³) had been processed in this manner, from which \$3,500,000 in gold was extracted (Mac Boyle, 1919).

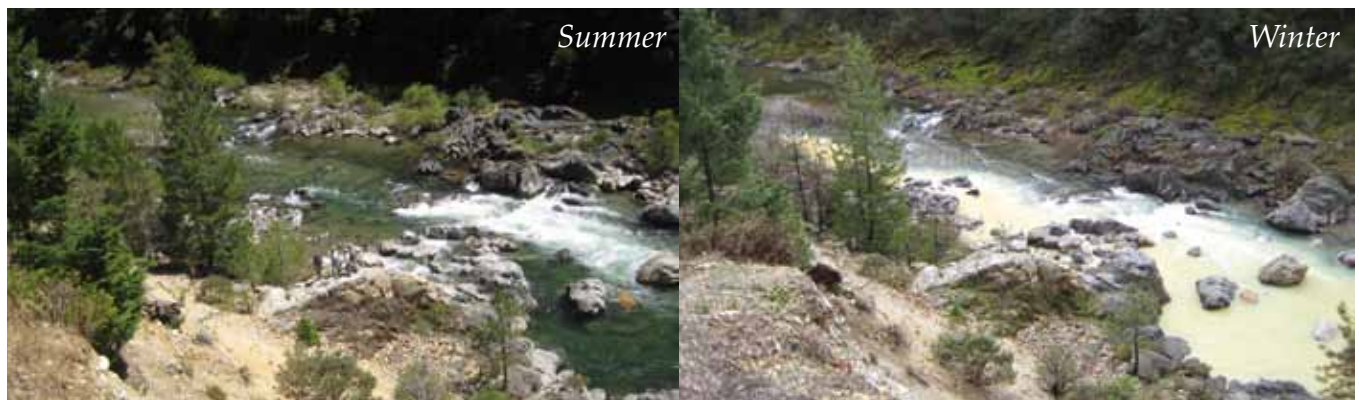
Figure 8. Confluence of Humbug Creek and the South Yuba River: Summer and Winter

Humbug Creek enters the South Yuba River at the top left of the photo. In the summer there is no visible mixing zone (photo taken July 12, 2011 by C. Monohan), in the winter after a storm event the mixing zone is yellow (photo taken Feb 3, 2012 by C. Monohan). The South Yuba River appears clear above the Humbug Creek confluence. The turbid water continues at least ten miles downstream at Edwards Crossing. The mine debris deposit that was the subject of USGS research is in the foreground of the summer picture.

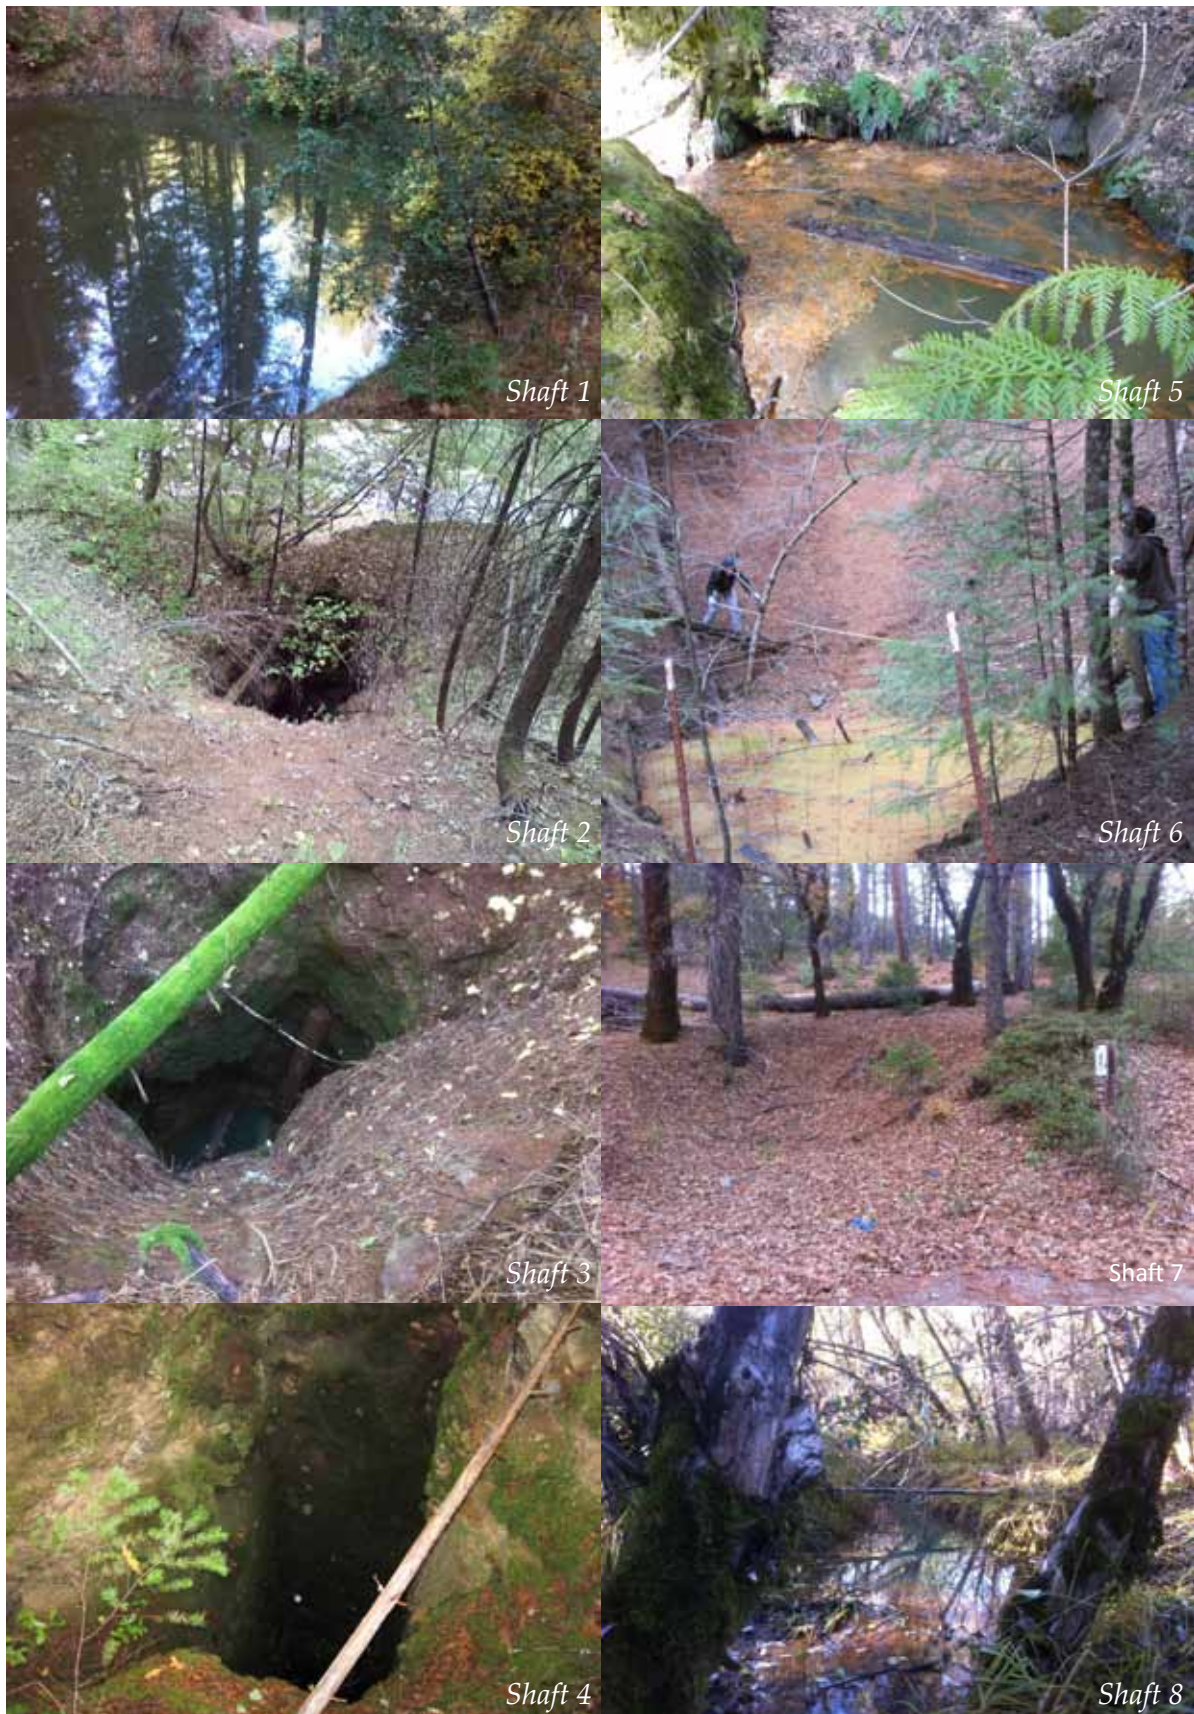
Figure 9. Access shafts Associated with the North Bloomfield Tunnel

There are eight access shafts that extend 250-440 feet below the surface to the horizontal North Bloomfield Tunnel. Some of them have standing water in them (Shaft 1, 2, 3, 4, 5 and 6) and some of them have collapsed or been filled in (Shaft 7 and 8). Shafts can present physical and chemical hazards. Shaft 5 and the North Bloomfield Tunnel outlet both have continuous discharge to Humbug Creek.

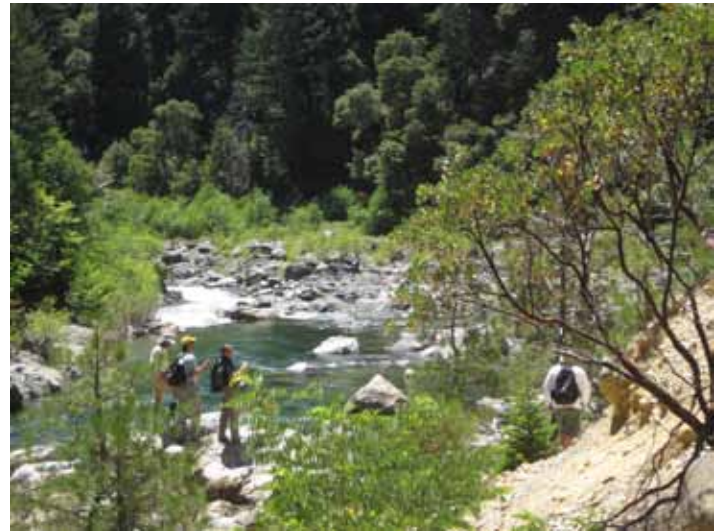
Figure 12. South Yuba River at the Confluence of Humbug Creek, Looking Downstream

The hydraulic mining debris deposit is on the right side in the photo. This deposit continues to erode into the South Yuba River during storm events. It contains mercury that can be transported downstream and methylated. (Photo taken July 12, 2011 by K. Morse.)

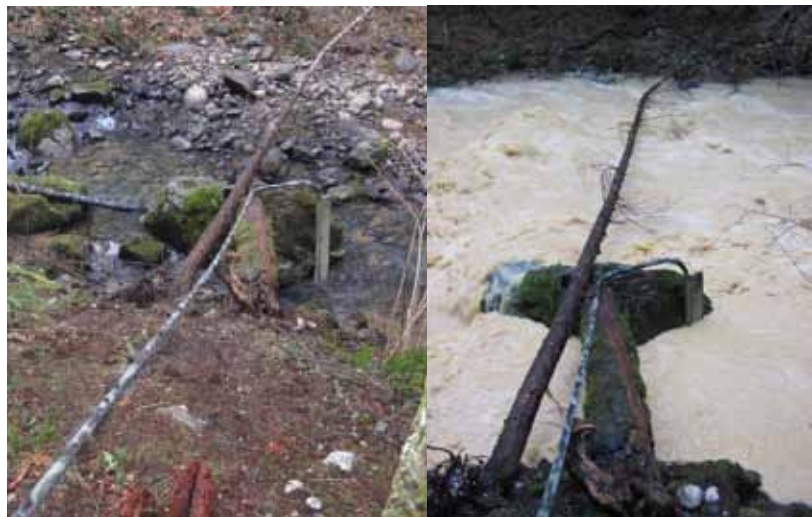
Figure 14. Gage Instruments in Humbug Creek at Gage 3 Site

The pressure transducer was installed in a 38 mm (1.5 in) PVC pipe with holes drilled in the side and no screen, which acted as a small stilling well of the meter, and is hereon referred to as stage. The turbidity meter's operational range was from 0-1,500 NTU (Forest Technology Systems (FTS), 2010). Grab samples were collected over the range of the turbidity meter's operational range and included the upper range of the meter (500-1,500 NTU) and when the turbidity meter had reached the extent of its operational range (>1,500 NTU). Samples were collected either by hand (grab samples) or were collected using an automated ISCO sampler (Teledyne ISCO 6712 Portable Sampler). During periods of high turbidity (March 2, 2012 and March 16, 2012 storm events), the automatic ISCO sampler was programmed to take water samples every four hours when the turbidity exceeded 900 NTU. The threshold 900 NTU was selected to represent the upper range of turbidity conditions while still ensuring that the meter was in a functional range of 900-1,500 NTU.

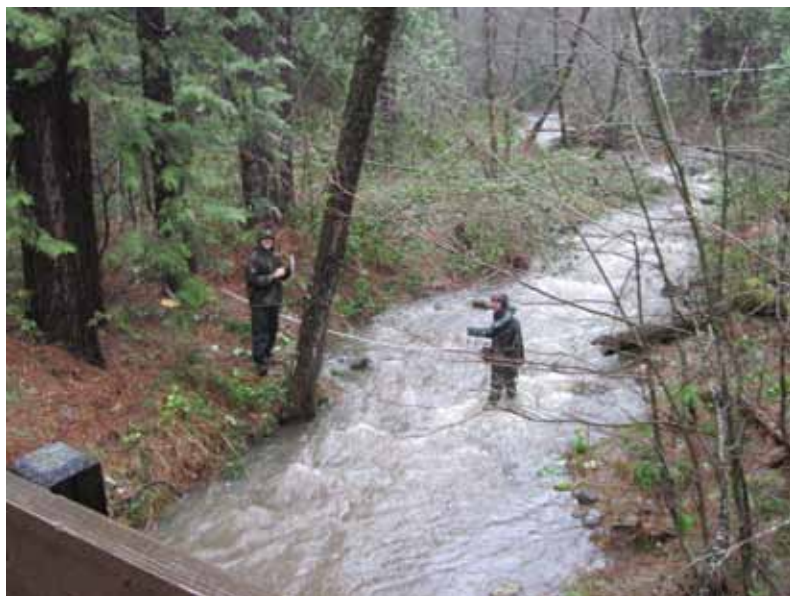
Figure 16. Discharge Measurement at Road 1, Humbug Creek
Discharge was measured using the Marsh McBirney flow meter model 2000 with top-setting wading rod. (K. Landrum (left) and H. Nepal (right) in photo; photo taken on March 15, 2011 by C. Monohan.)

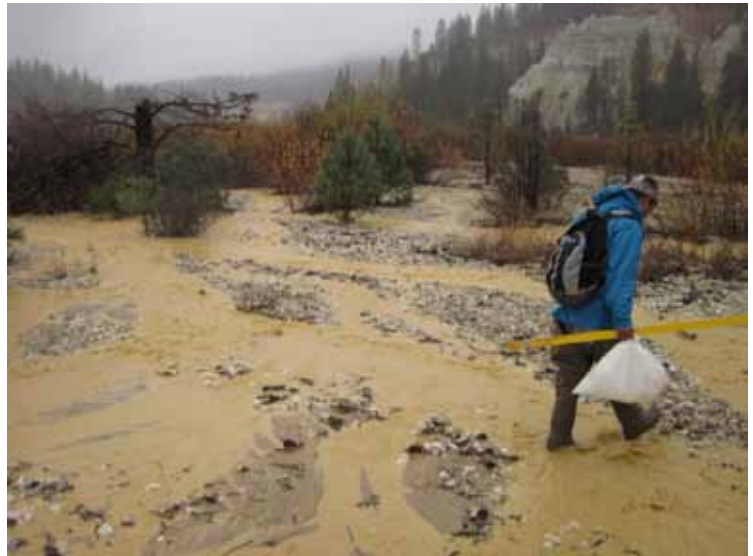
Figure 17. Surface Flow in the Malakoff Diggins Pit

- SS1 to SS4 are in drainages to the east of the Hiller Tunnel inlet that drain relic mine tailings on the south rim of the pit.
- SS5 to SS11 are in the actively eroding area of the east end of the pit. SS5 captures the spring discharge and SS11 is in an area that may capture drainage from placer tailings. SS6 and SS9 are background samples.
- SS12 to SS15 are background samples. SS12 and SS13 (northeast pit rim drainages) are in background locations, SS15 is a background location from a drainage that enters from the northwest end of the pit.
- SS18 to SS21 are near Hiller tunnel. SS18 is at the tunnel inlet, SS19 captures flow from the east end of the pit, SS20 captures flow from the west end of the pit, SS21 is at the tunnel outlet.

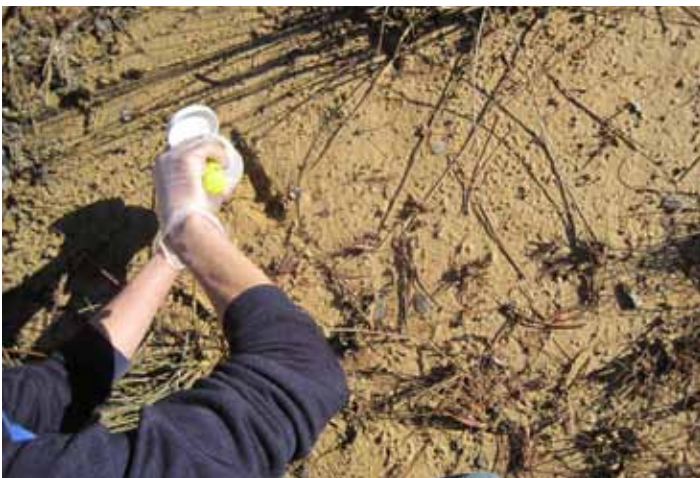
Figure 18. Confirmation Soil Samples from the Malakoff Diggins Pit

Confirmation soil samples were collected from areas that had elevated concentrations of particulate-bound mercury in suspended sediment during the December 2, 2012 stormwater sampling day. (Photo taken January 14, 2014 by K. Atkins of C. Monohan.)

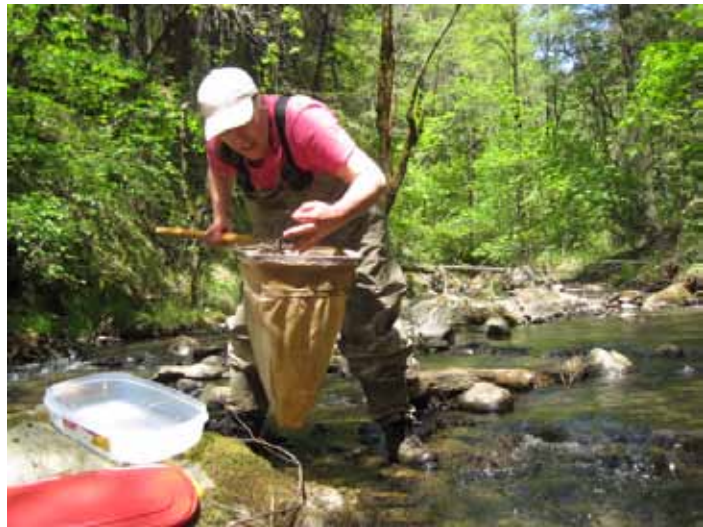
Figure 20. Macroinvertebrate Sampling, Humbug Creek
Water Striders (*Gerridae*) were collected from Humbug Creek. (Photo taken May 18, 2012 by C. Monohan; S. Miller depicted.)

The three 150 m (492 ft) reach sections were located in Humbug Creek: 1) upstream of the confluence with Diggins Creek at the Relief Hill Road crossing (Road 1), 2) 30 m (100 ft) downstream of the confluence at the gage location (Gage 3), and 3) downstream of the Shaft 5 discharge into Humbug Creek. (Additional macroinvertebrate data were collected as part of Susan Miller's CSU Chico thesis, but at the time of writing this report are not available.)

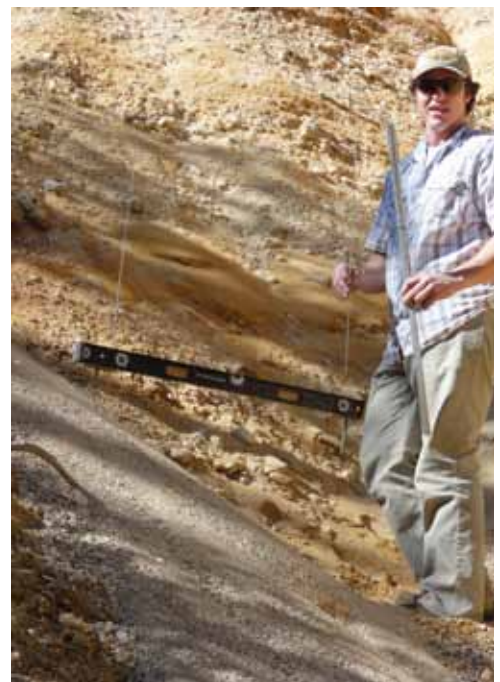
Figure 21. Erosion Bridges in the Malakoff Diggins Pit

The results of these erosion measurements and GIS analyses of representative units were combined to calculate an annual sediment yield from the pit. Representative units were defined as areas of similar morphology and were delineated through observations within the pit and related to areas on the map image using landmarks, such as individual gullies or landslides as reference markers. Multiplying elevation change by the area of similar slope and soils type yields a volume of sediment eroded for that area.

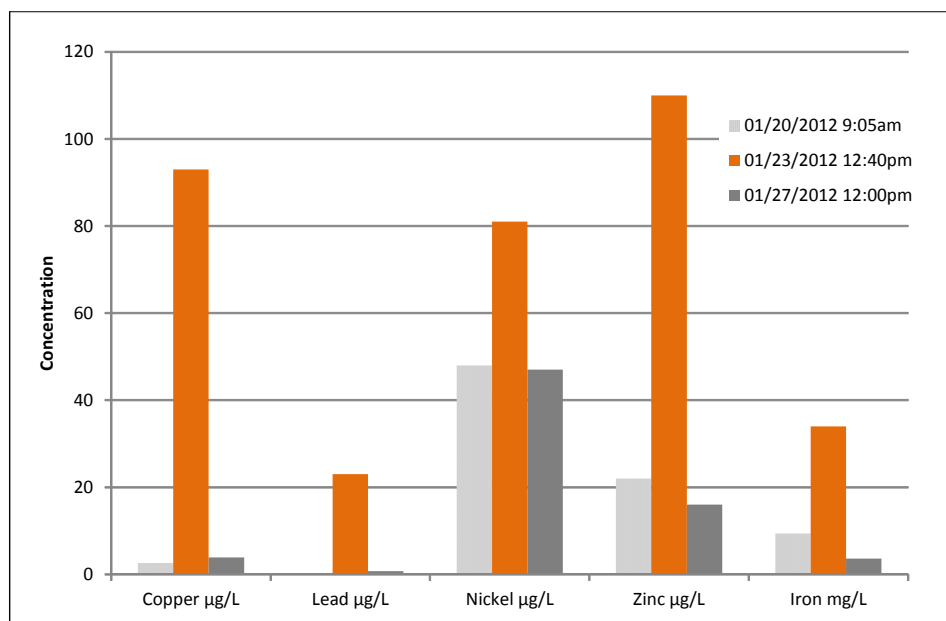
Figure 25. Metals in Hiller Tunnel Storm Event Discharge, January 2012 Storm

Hardness as CaCO₃ was 65.90 mg/L on 2/9/2014

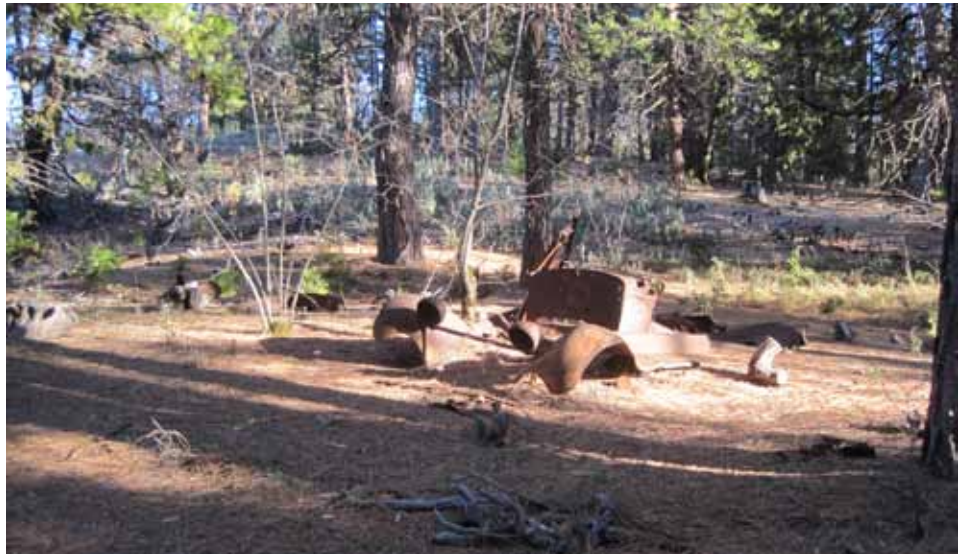
Figure 32. Malakoff Village Site

Confirmation samples collected from the Malakoff Village site found mercury at 4,160 ng/g (4.16 ppm) and 6,330 ng/g (6.33 ppm) in the soil at locations where mercury was stored (approximate location of the office) and where it was applied nearby. Future soil samples should be guided by an archeologist's understanding of historic mining operations. (Photo taken in 2013 by M. Selverston.)

Additional mercury sources may also exist. For example two soil samples taken from the old Malakoff Village Site along the south rim of the pit (Malakoff Confirmation soil samples 11 and 12) (Figure 29 on page 73, Table 8 on page 79), had 4,160 ng/g (4.16 ppm) and 6,330 ng/g (6.33 ppm) total mercury. This indicates that additional source areas for mercury need to be investigated and it is recommended that investigation be coordinated with the archeological findings on how and where mining operations that used mercury took place in the watershed. It is also recommended that additional samples be collected to identify locations that contribute to the particulate-bound mercury concentrations.

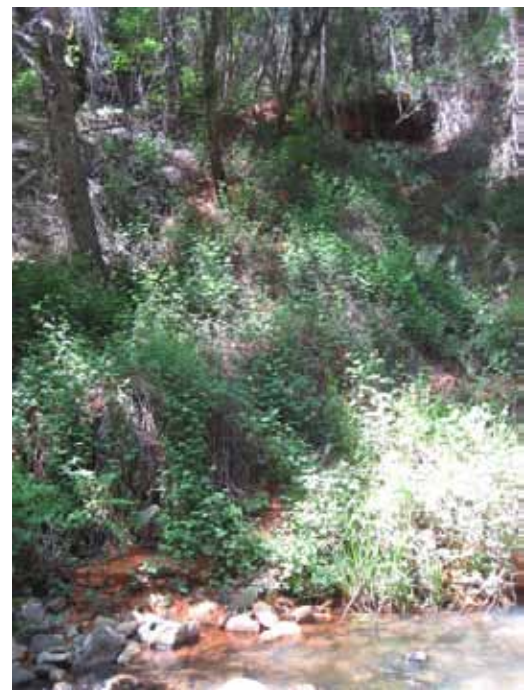
Figure 33. Shaft 5 Discharge to Humbug Creek
Shaft 5 is the only access shaft that has discharge to Humbug Creek as surface flow.

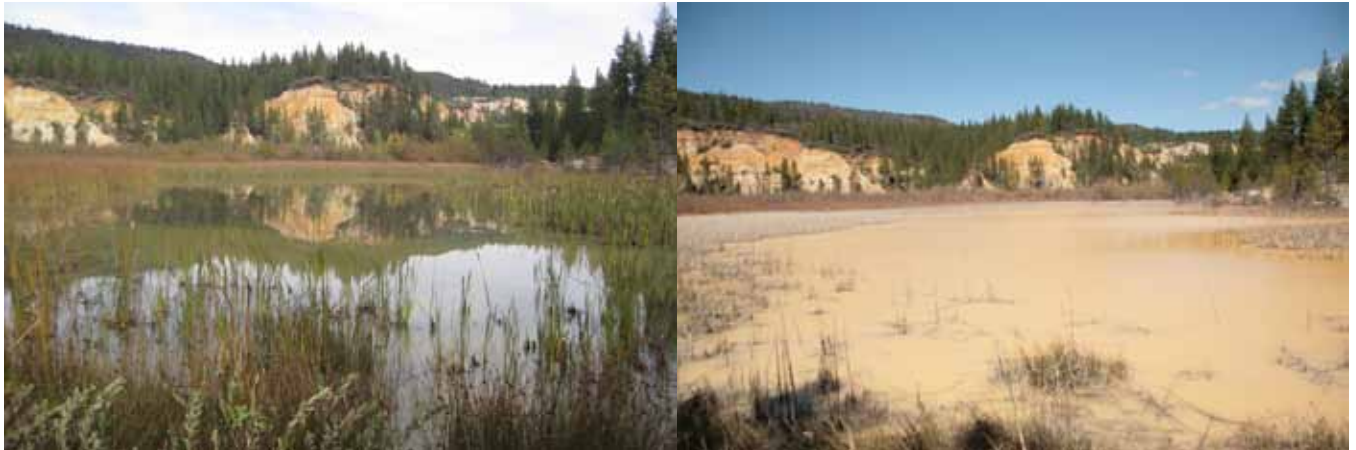
Figure 40. Malakoff Diggins Pond

The pond in the Malakoff Diggins pit is in the far west end of the pit. It drains to Hiller Tunnel. The pond is clear in the summer and turbid during the rainy season. (Photo taken on November 9, 2011 (dry) and April 6, 2012 (wet) by C. Monohan.)

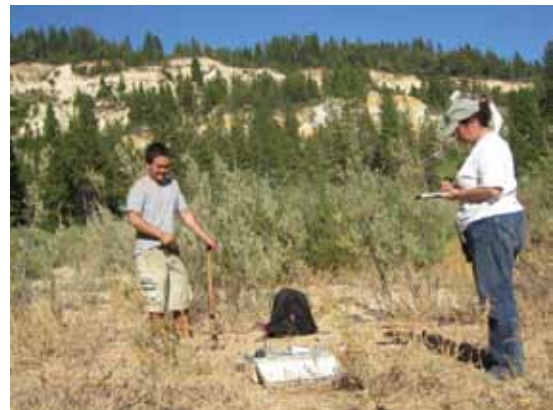
Figure 42. Seismic Surveys in the Pit

Seismic surveys were conducted at the same locations in the east end of the pit where Peterson conducted seismic surveys in 1979. The vegetation made it difficult to register a contact with bedrock, and some transects were not accessible because of dense vegetation growth on the pit floor. (Photo taken on September 22, 2012 by C. Monohan; D. Demaree and C. Liggett are depicted.)

The seismic survey was conducted at the same location on two different dates with two different geophone spacings. In one case, using a 0.9 m (3 ft) spacing for the geophones, the contact depth was 4.11 m (13.5 ft) deep. (The upper unit had a velocity of 339 m/s, consistent with unsaturated sand, and the lower unit had a velocity of 1,565 m/s, consistent with saturated sand.) In the second case, using a 9.1 m (30 ft) spacing for the geophones, the contact depth was at 3.7 m (12 ft). (The upper unit had a velocity of 479 m/s, consistent with unsaturated sand, and the lower unit had a velocity of 1,135 m/s, consistent with saturated sand.) It is clear that neither of these surveys reached the depth to bedrock. However, the saturated zone in the pit during the dry season is a useful tool to understand the hydrologic function of the pit.

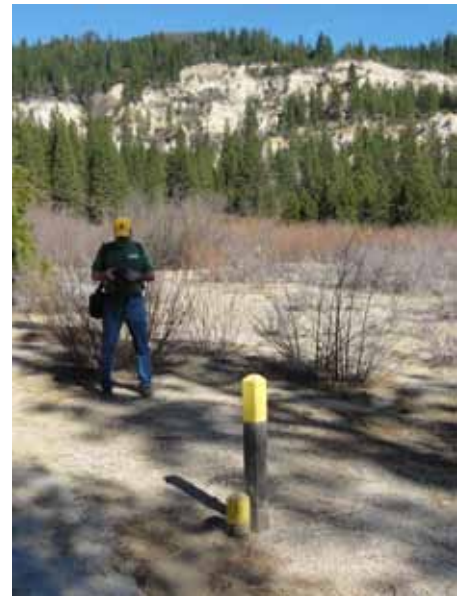
Figure 44. Deposition in the Pit

Trail markers installed by DPR were used as deposition stakes markers throughout the pit. The old trail markers were measured in 2005 when new trail markers were installed. (Photo taken October 29th, 2013 by J. Howle; C. Alpers depicted for scale.)

There are four stake transects placed by DPR in the alluvial plain where streams draining gully networks converge and braid together in an alluvial plain with a 10 degree slope. The average deposition over the 8-year period in the east side of the pit floor zone was measured at 53 mm/yr, ± 6 mm. This area was measured using the ArcMap 10 area measure tool. The area

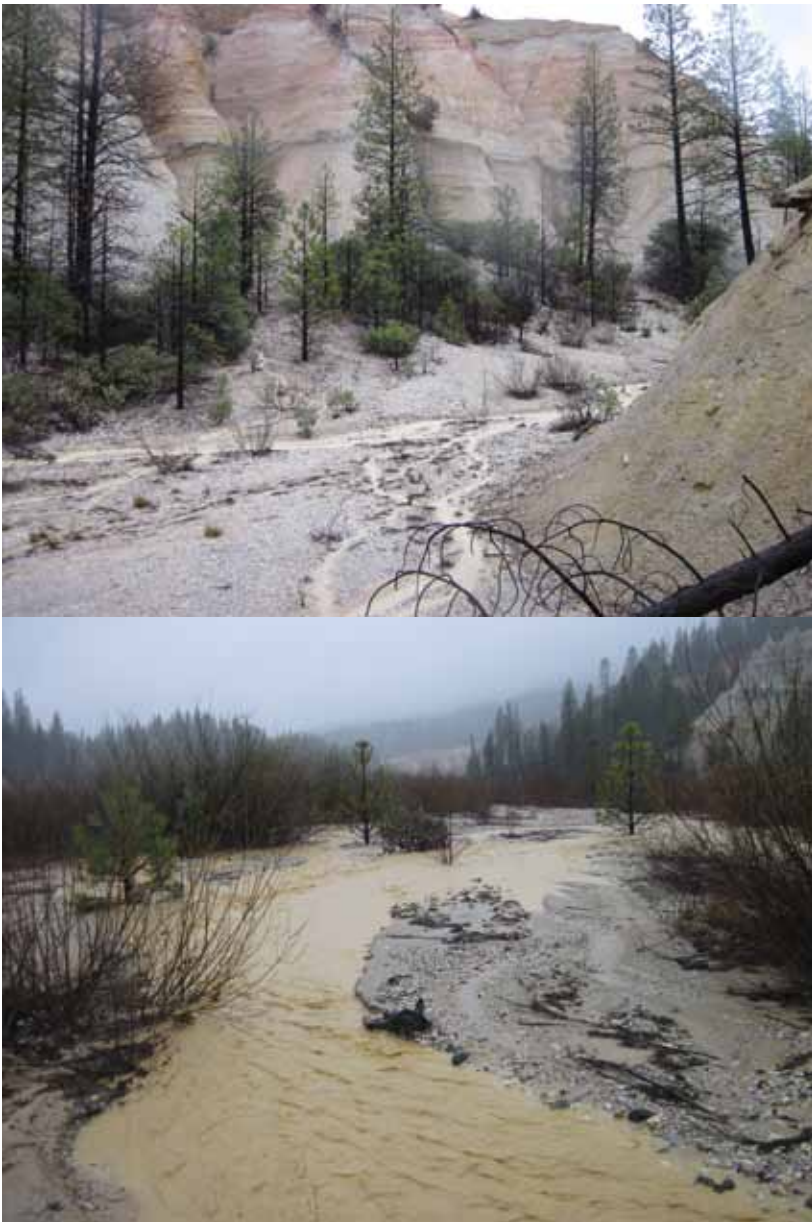
Figure 50. Overland Flow along the Malakoff Diggins Pit Floor

Areas of bare mineral soil continue to be impacted by rainsplash and sheetwash. The pit floor in the east end of the pit shows surface flow accumulation (upper panel) surface flow accumulates significantly moving west toward Hiller Tunnel (lower panel). (Photos taken on March 17, 2011 by D. Brown.)

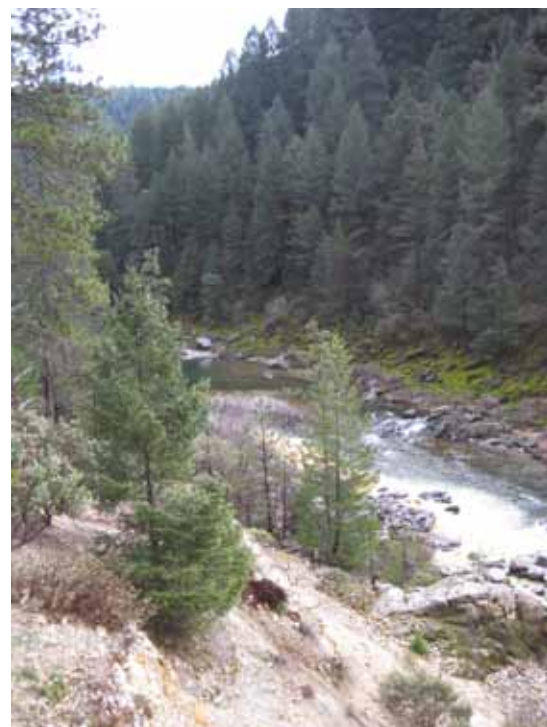
Figure 55. Identifying Mercury Sources

Humbug Creek is a source of mercury-contaminated sediment to the South Yuba River, and identifying sources in the headwaters and remediating them at the source can protect miles of downstream habitat. (Photo taken on March 23, 2012 by C. Monohan.)

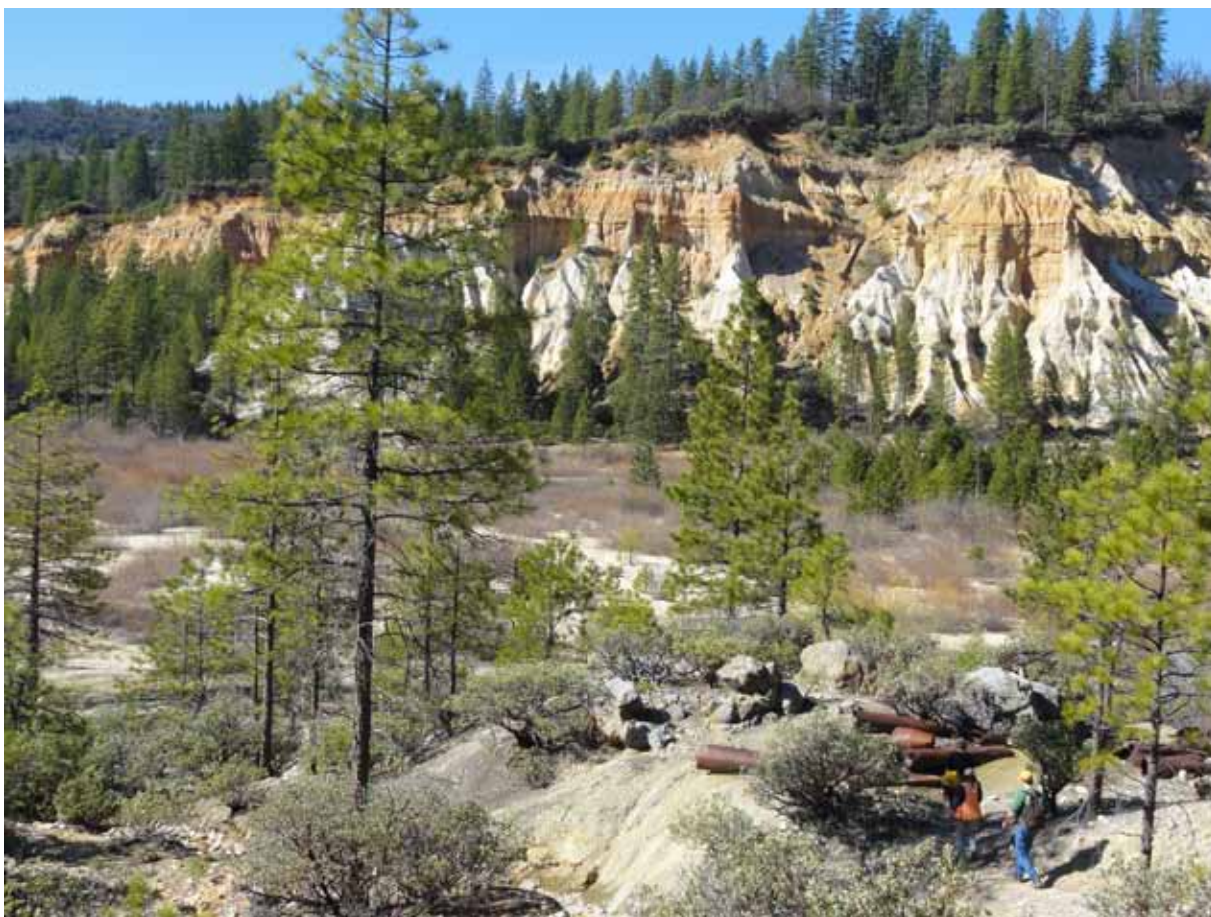
Figure 58. Soil Pathway Targets

Recreational trails traverse mine-impacted landscapes throughout Malakoff Diggins State Historic Park. (Photo taken on October 29, 2013 by J. Howle.)

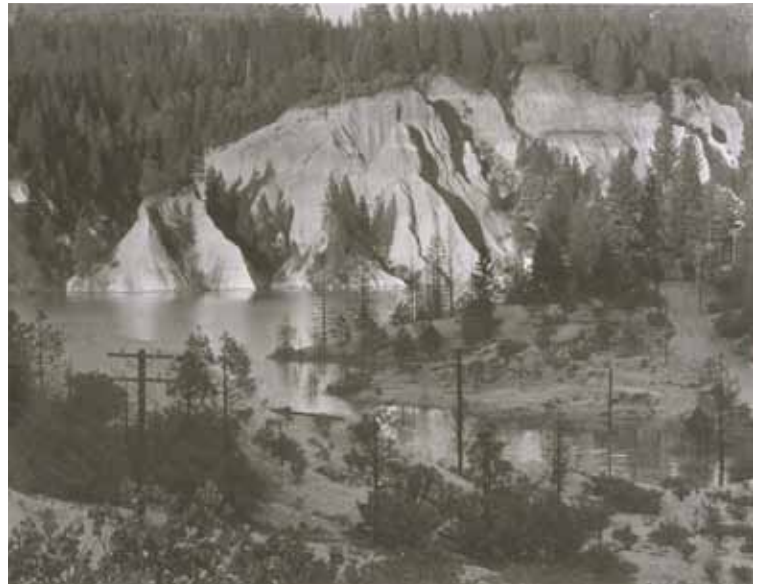
Figure 63. Malakoff Diggins Pit, Flooded, 1954

This photo demonstrates the changing nature of the Malakoff Diggins pit over the last century. A water and sediment detention structure near the inlet of Hiller Tunnel may return the pit to similarly flooded conditions. (Photo by Alma Lavenson; courtesy of The Bancroft Library, University of California, Berkeley; BANC PIC 1987.021:285-PIC.)
